**No. AS350-63.00.38**

# ALERT SERVICE BULLETIN

**MAIN ROTOR DRIVE - Main Gear Box (MGB) engine coupling**  
**Check the correct assembly of the MGB engine coupling flange**

The purpose of this ALERT SERVICE BULLETIN is to check the assembly direction of the flange and to correctly re assemble it if necessary.

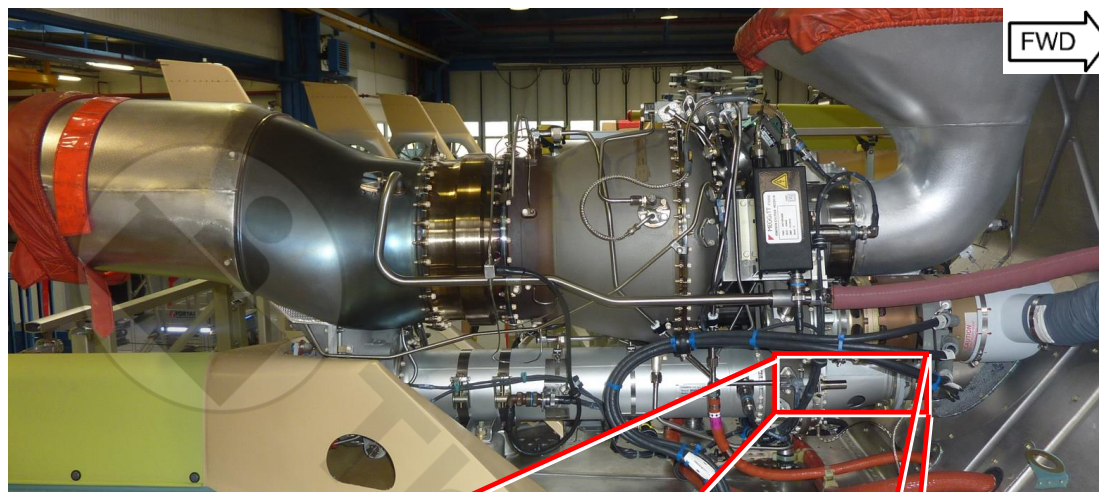
Figure 1

- Position the endoscope (zz) through inspection access hole of engine housing (a) (Figure 1 and Figure 2).

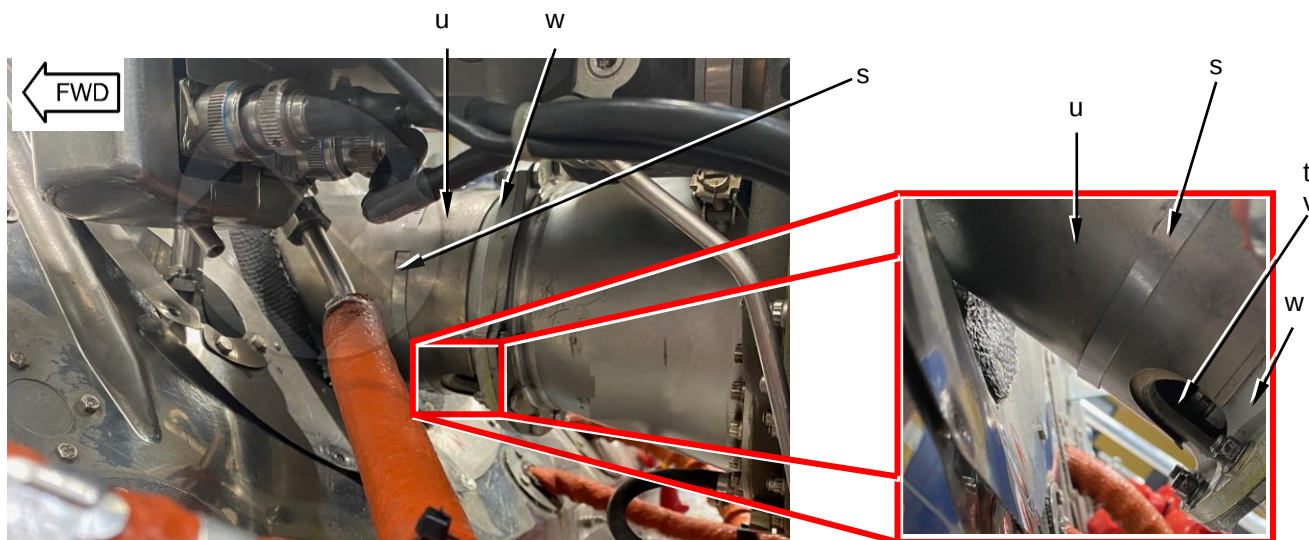
Figure 3

- Access through the engine coupling housing
- Loosen the clamps (s) of the protection plate (u).
- Align the hole (t) of the protection plate (u) with the inspection hole (v) of the engine coupling housing (w).
- Position the endoscope (zz) (not shown) through inspection access hole of the protection plate of the engine coupling housing (w) (Figure 3).

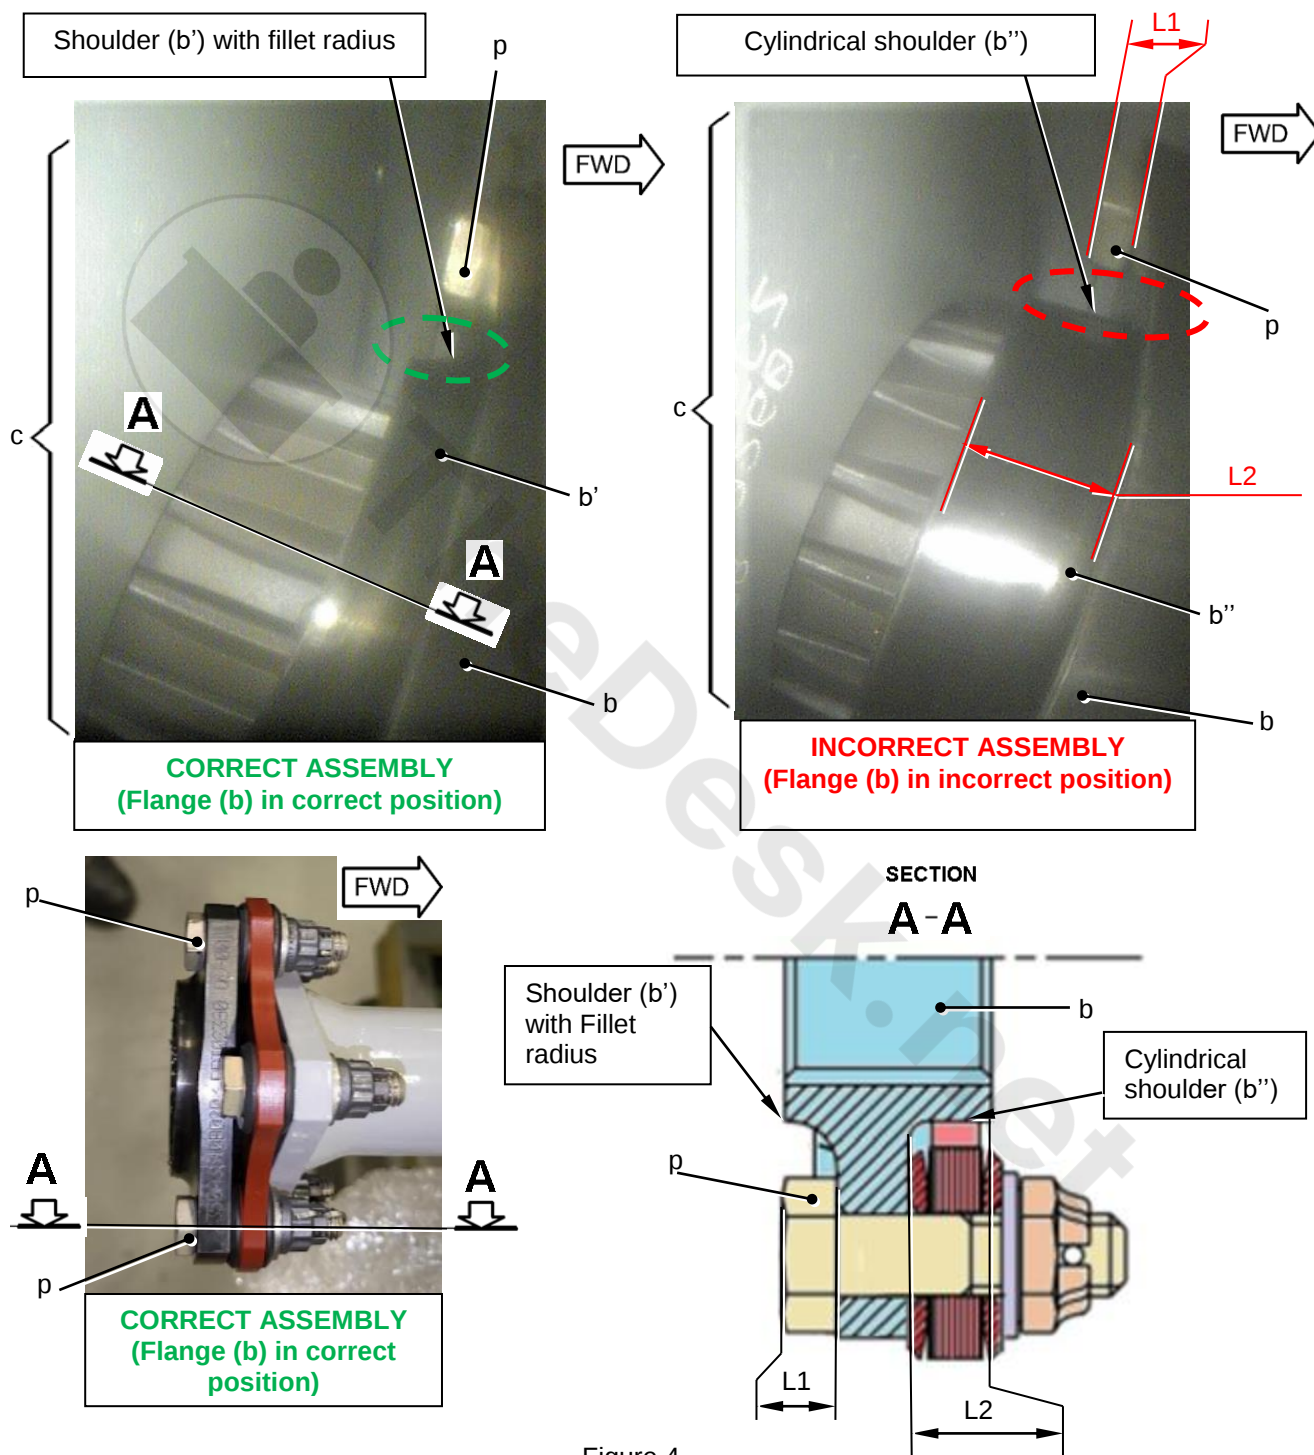
Figure 4

- Make sure that the flange (b) of MGB engine coupling (c) is correctly assembled with the endoscope (zz) (Figure 4 and Figure 7).

*Incorrect assembly can be identified with a check of relative length (L1) of the head (p) of the screw and the length (L2) of the shoulder (b''). The head (p) of the screw is two times shorter than the shoulder (b'') ([Figure 4](#) and [Figure 7](#)).*

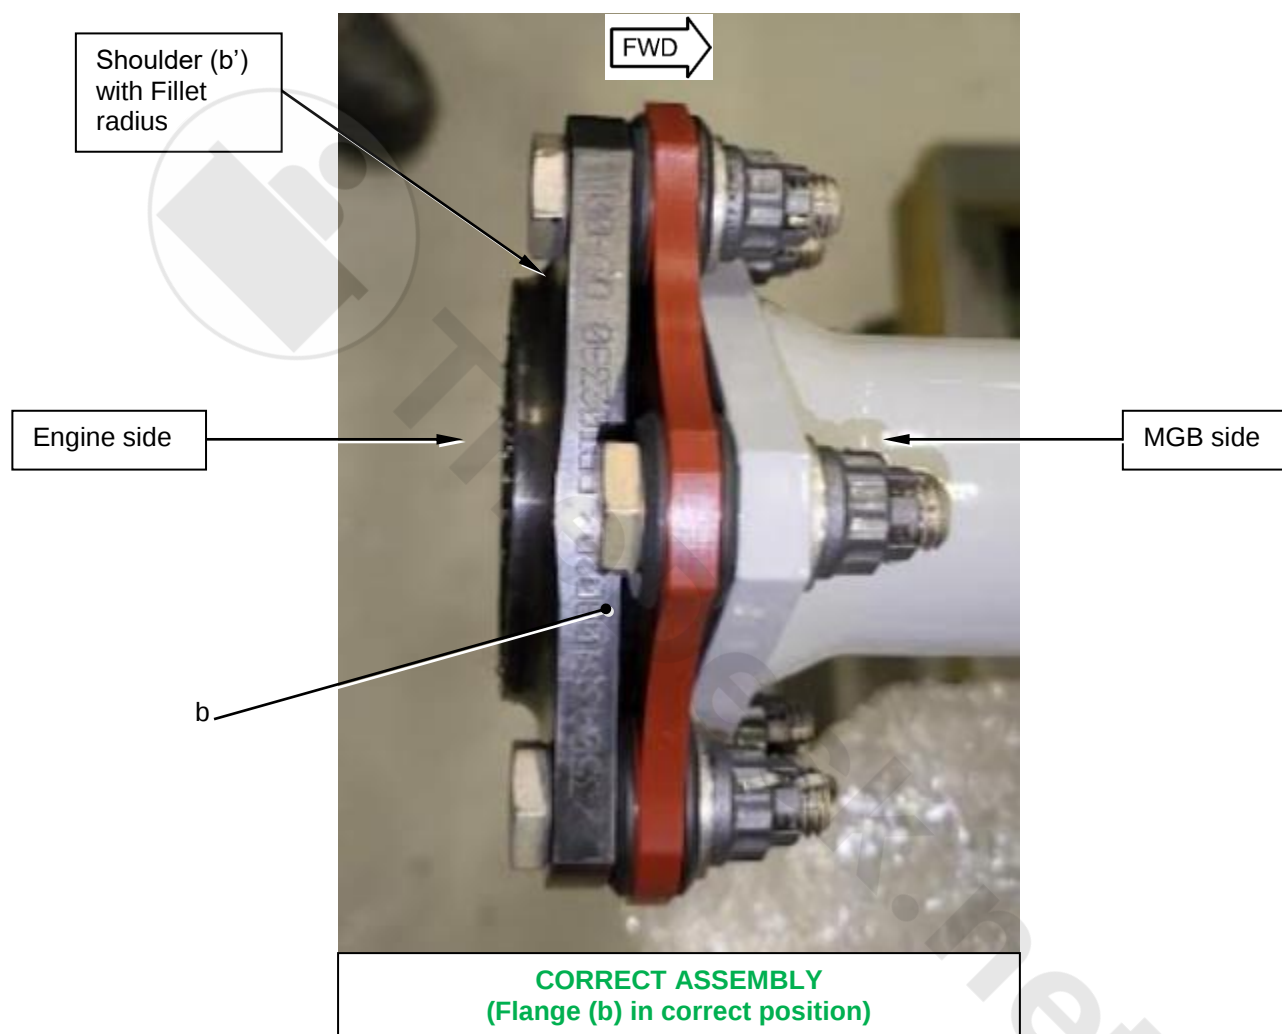
Figure 5

- If the flange (b) is correctly assembled (Figure 5 and [Figure 7](#)):
  - . Remove the endoscope (zz) (not shown) from the inspection access hole of the engine coupling housing (a).
  - . If necessary:
    - .. Position the hole (t) in the protection plate (u) so that it closes the inspection hole (v) in the engine coupling housing (w) ([Figure 3](#)).
    - .. Tighten the clamps (s) of the protection plate (u).
  - . Comply with paragraph [3.B.3](#).
- If the flange (b) is incorrectly assembled:
  - . Comply with paragraph [3.B.2.d](#).

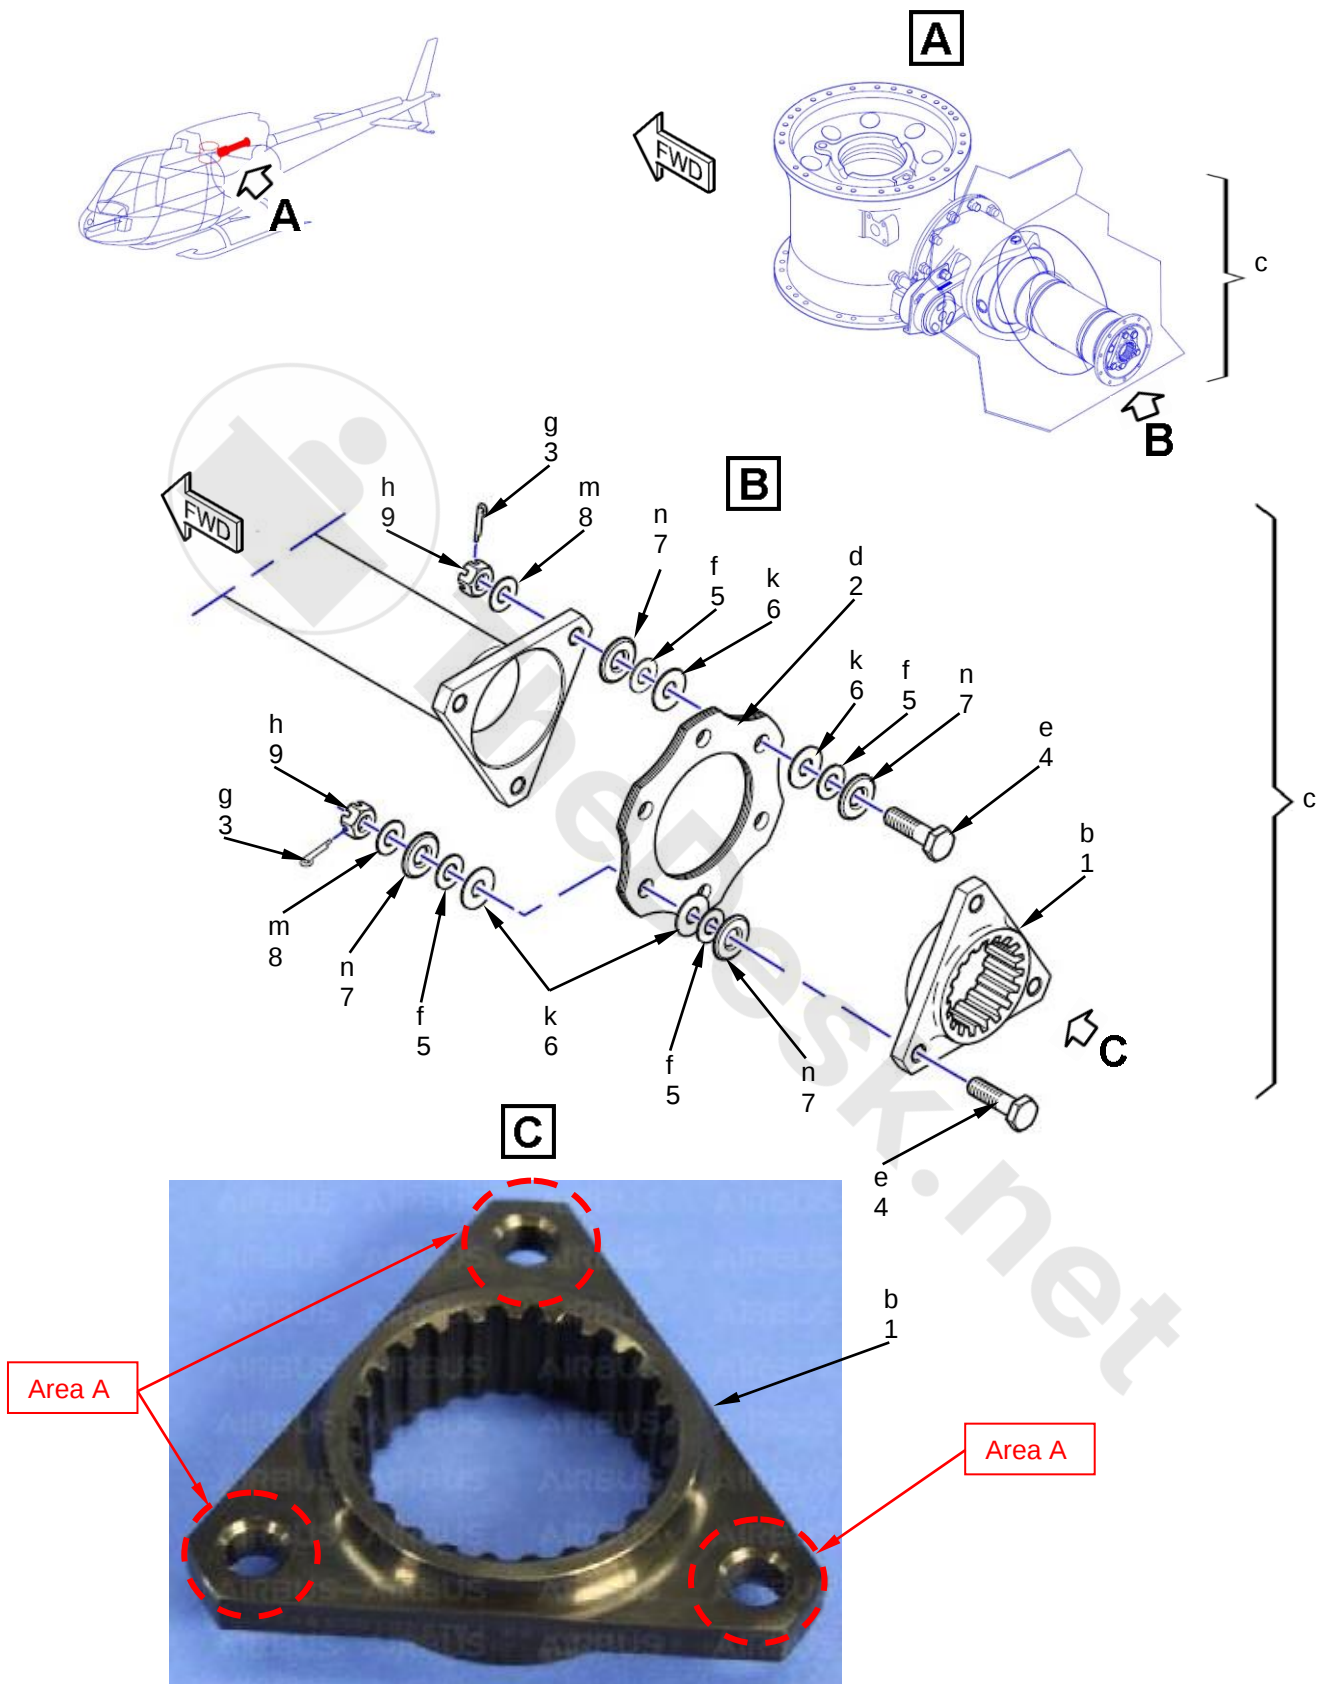
Figure 6

**FOR CORRECT INSTALLATION OF THE FLANGE (b) OR (1), THE HEADS OF THE SCREWS (4) MUST BE ON THE CHAMFER SIDE (AREA A). REFER TO DETAIL C.**

- Refer to Work Card 63-00-00-401 (MET) or Task 63-11-00, 4-1 (AMM):
  - . Remove the MGB engine coupling (c) from the helicopter.
  - . Remove the flange (b) and the flexible coupling (d) from the MGB engine coupling (c).
- Discard:
  - . The screws (e)
  - . The washers (f), (k) and (m)
  - . The washers flexor (n)
  - . The nuts (h)
  - . The pins (g).
- Do an inspection of the flange (b) of the MGB engine coupling. Refer to Work Card 63-00-00-616 (MET) or Task 63-11-00, 6-9 (AMM).
- Do an inspection of the flexible coupling (d) of the MGB engine coupling. Refer to Work Card 63-00-00-616 (MET) or Task 63-11-00, 6-1 (AMM).

- Refer to Work Card 63-00-00-401 (MET) or Task 63-11-00, 4-2 (AMM):
  - . Install the flange (b) or the new flange (1) and the flexible coupling (d) or the new flexible coupling (2) on the MGB engine coupling (c) with:
    - .. The new screws (4)
    - .. The new washers (5), (6) and (8)
    - .. The new washers flexor (7)
    - .. The new nuts (9)
    - .. The new pins (3).
  - . Install the MGB engine coupling (c) correctly assembled on the helicopter.
- Send the response form to Airbus Helicopters (see Appendix [4.A.](#)).
